U.S. Department
Of Transportation

**Federal Railroad
Administration**

Reply to Att. of: **MP&E 01-02**

Subject: Guidance for Inspection for Locomotive Draft Gear Pocket Center Sill Connection Plate
Cracks During Daily and 92-Day Periodic Inspections

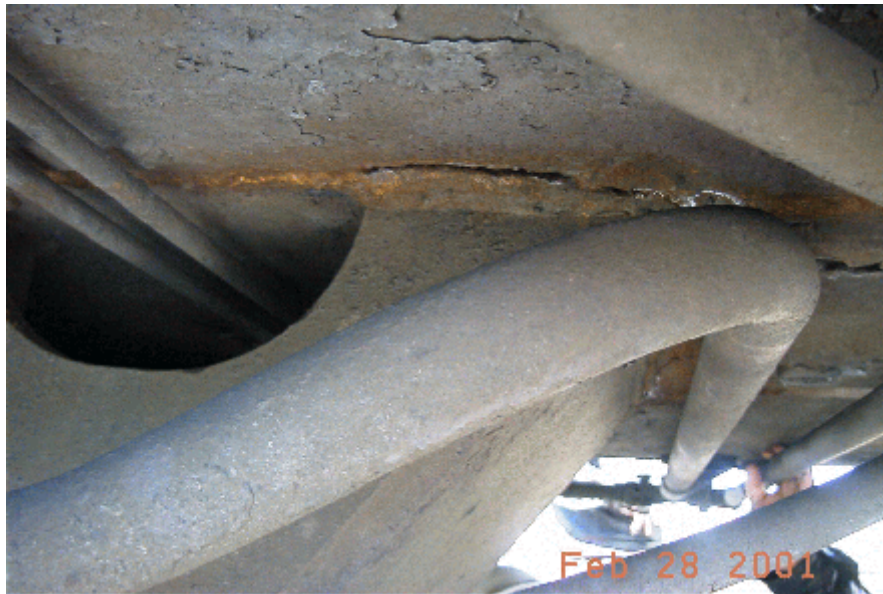
Recently, there have been a number of locomotives discovered with cracks in the center sill connection plate in the area where the draft pocket is secured to the under frame of the locomotive. These cracks are developing in the plate steel, not in the securement welds (see figures 1 & 2). When the cracking progresses far enough, the coupler face drops and the backside of the draft pocket is forced up between the center sills. Catastrophic failure results in separation of the draft unit from the locomotive (see figure 3).

The cracks are visible to the naked eye as shown in the photographs. Photograph 1&2 were taken with an idler truck under the locomotive, but cracks can be seen with standard locomotive trucks in place.

Fig. # 1 Crack at the rear connection of the draft gear pocket extending past piping.

These cracks can be observed during the daily inspection, but are best seen when a locomotive is placed over an inspection pit or on raised track during the 92-day periodic inspection. At least two Class I railroads have issued additional instructions to do a better inspection of draft gear pocket the area during 92 day periodic inspection.

The current locomotive safety standard [49 CFR 229.23] requires “that at each periodic inspection a locomotive shall be positioned so that a person may safely inspect the entire underneath portion of the locomotive”. It is at this time that a thorough visual inspection of the draft pocket area should be performed.

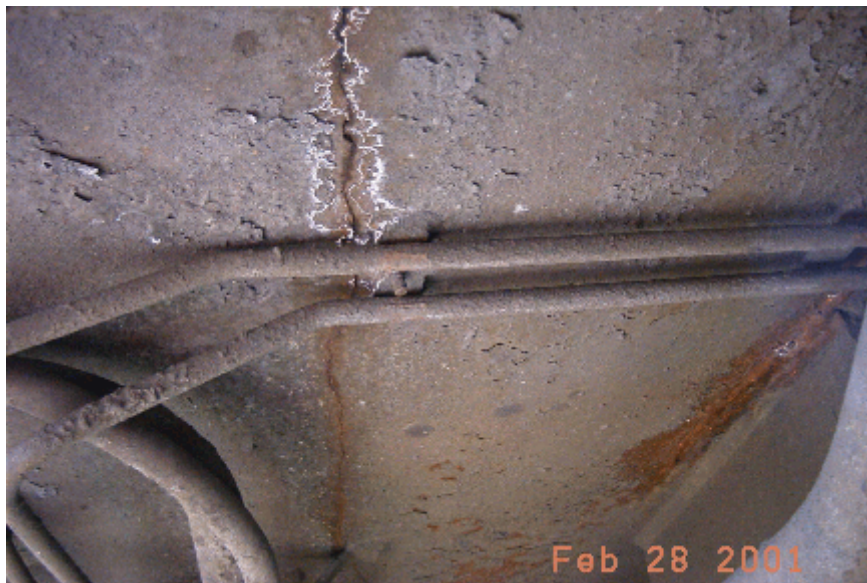
Fig. # 2 Crack in the connection plate along side draft gear pocket.

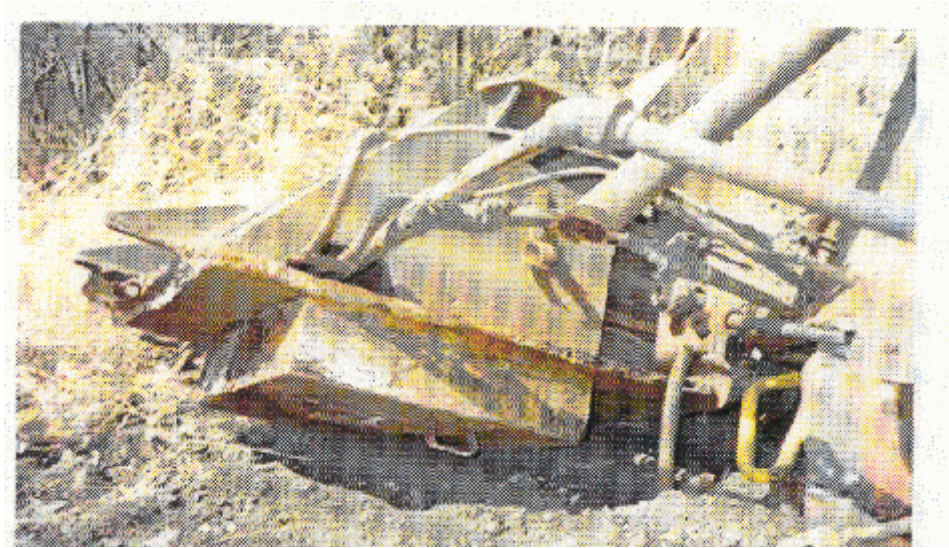
Fig. # 3. Catastrophic failure resulting in separation of the draft unit from the locomotive.
